## 2023 Aquatic Plant Survey and Invasive Species Detection Report

*Big Sand Lake*

Prepared for the Big Sand Lake Association

Survey by Aquatic Survey Professionals – MN DNR Certified Aquatic Plant Surveyors

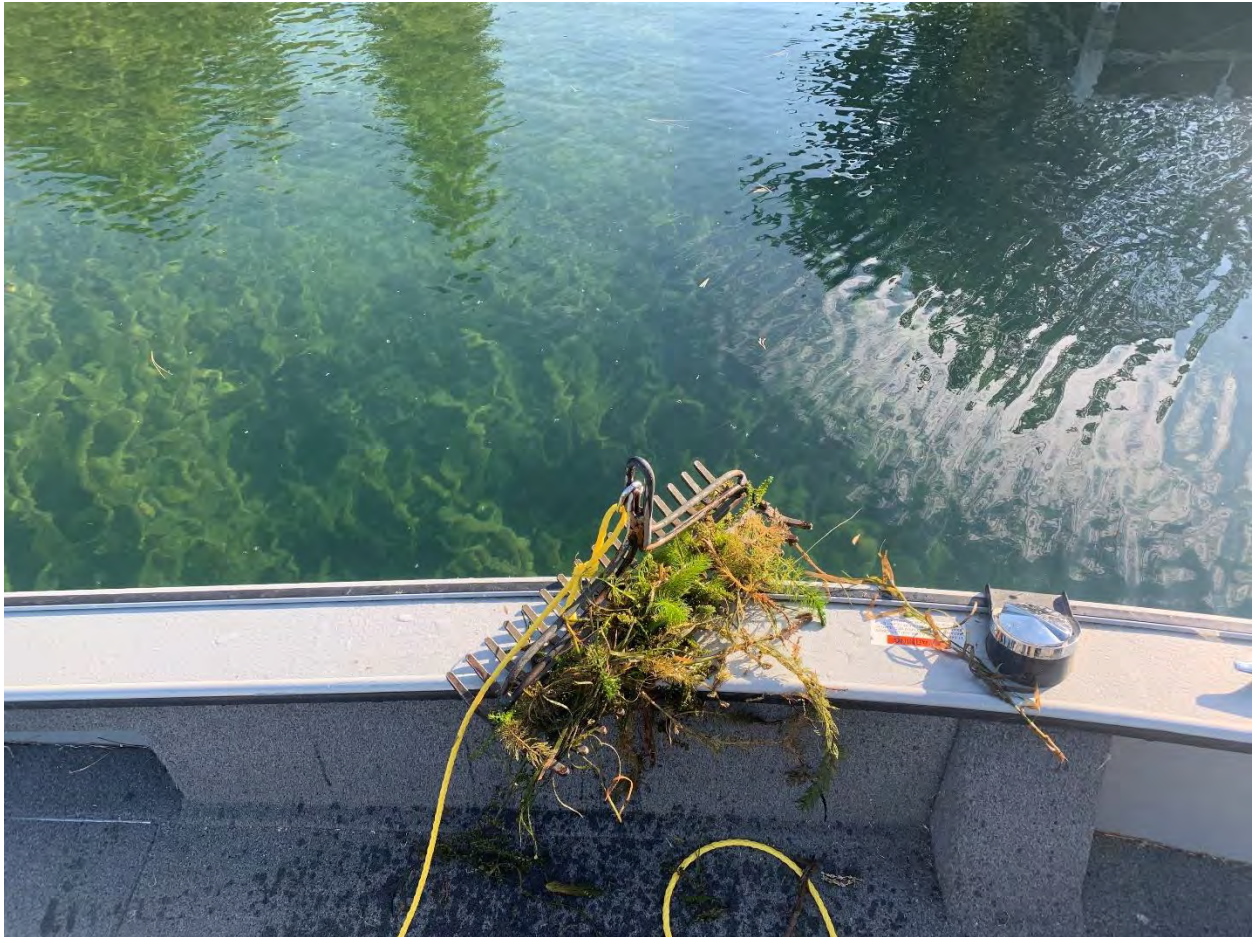
The sample rake collected at Pine Cone Lodge with the aquatic community visible.

The bay and point in front of Pine Cone Lodge were searched carefully for any invasive species. There is a dramatic difference between the rocky point and the lake bottom in the bay which has collected sediment and nutrients over the years. The bay features diverse native vegetation that starts at depths of 5 feet and includes Northern Water Milfoil, Wild Celery, and

Whitestem Pondweed, see the picture below. Emergent aquatic plants are found along the Pine Cone Lodge shoreline demonstrating the environmental stewardship of the residents here and their efforts to limit impacts on the lake. No invasive species were found in this area.

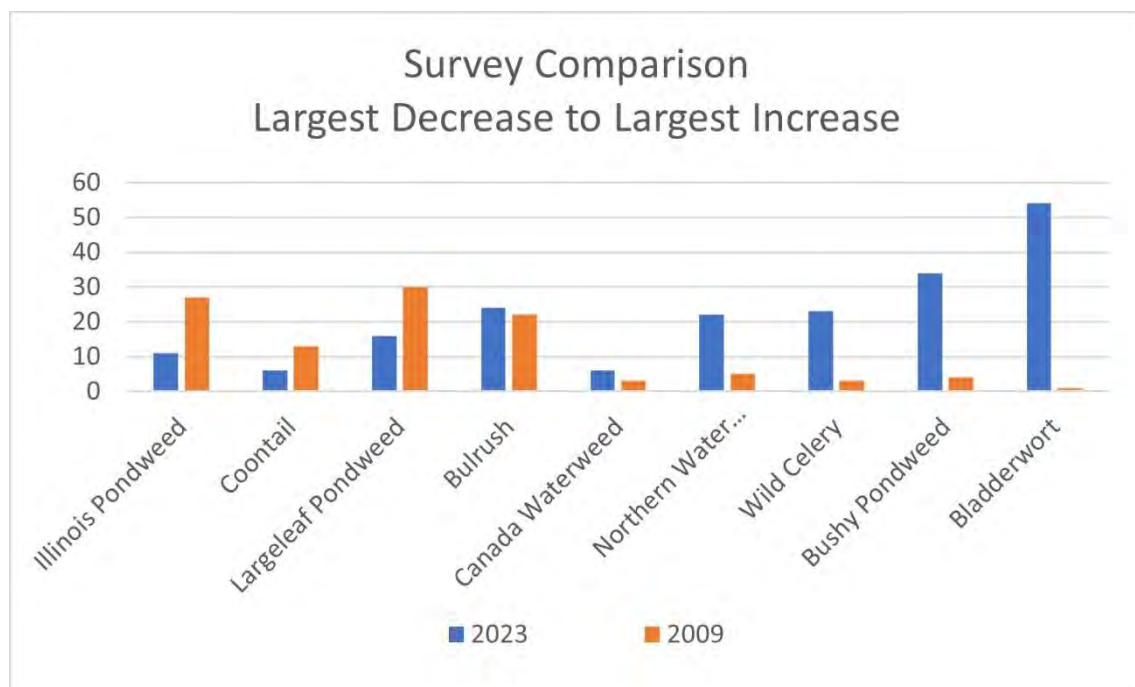
Comparing the surveys it appears that disturbance tolerant species are increasing in coverage. Species intolerant to disturbance have generally remained steady to slightly declined. Coontail is the exception to this since it is tolerant to disturbance but has declined in abundance. This trend was also seen in Long Lake where Coontail declined, contrary to the trend observed in that lake of generally increases in species tolerant to disturbance. The increase in Bladderwort is the most obvious since this species is readily sampled using standard rake sampling techniques and should have shown up in the 2009 survey if present. Wild Celery has been increasing in general across Minnesota and that pattern is also seen in Big Sand Lake.

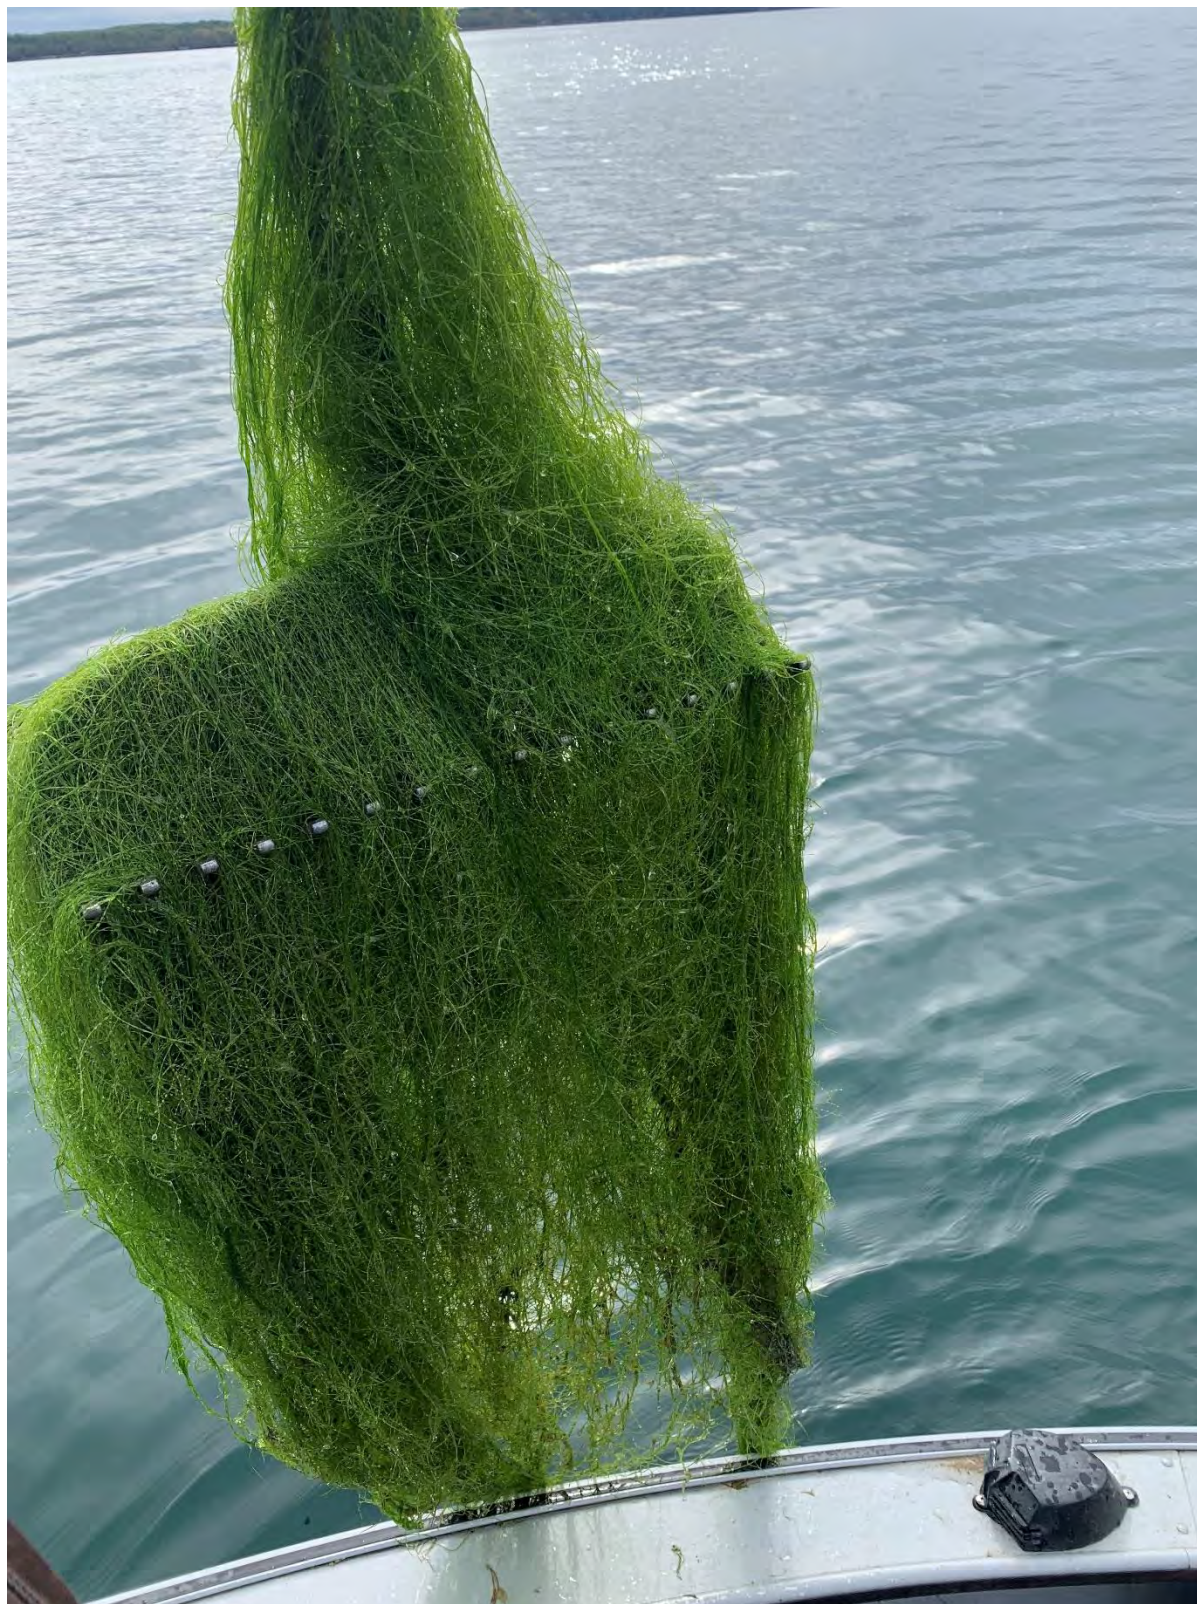
Dense Nitella Sampled at 28' along the Northeastern Shoreline of Big Sand Lake
